Influence of glacial retreat on natural hazards of the Palcacocha Lake area, Peru

Abstract In this article we describe natural hazards associated with outburst floods of Palcacocha Lake and landslide events on the slopes of its moraine dam, in Cojup Valley, Cordillera Blanca (Peru). These events occurred in the last 70 years and some of them resulted in disasters, which strongly affected the city of Huarás. Field investigations and reference expression hydrodynamic tests as well as archive satellite images and aerial pictures were used to describe the evolution of hazards connected with Palcacocha Lake. Expression hydrodynamic tests proved a high permeability of sandy gravels glacial sediments, which form the present-day lake dam. Seepage through the natural dam forming small ponds below the overflow spillways occurs. A retreat of the glacial tongue causing an increase of the lake volume and unloading of the slope toe areas are the most important recent processes that influence the potential hazards affecting the Cojup valley. The research has proved that the climate warming and ongoing deglaciation play a very significant role in the change of natural hazards conditions in high m

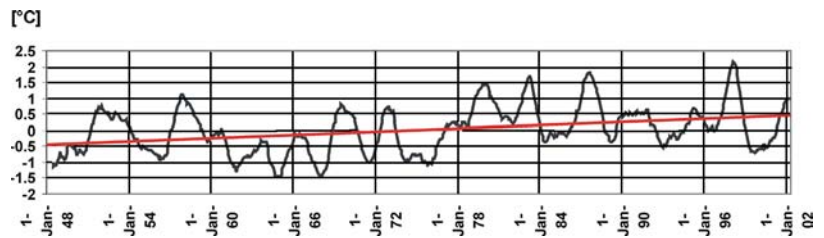
Fig. 2 Monthly average temperatures recalculated for the Cordillera Blanca Mountains for altitude of 6000 m a.s.l. with linear trend line in red (modified after B. Pouyaud, IRD, France, from archive of N. Santillán)

The 2003 events along with evidence of ongoing climate warming (e.g. Kaser 1999; Rodbell and Seltzer 2000; Kaser et al. 2003; Fig. 2) showed the need for new moraine dam stability investigations of the Palcacocha Lake. The main task was to evaluate whether a potential outburst flood would be able to reach the destruction intensity of the 1941 event with respect to the increasing population density of the formerly affected areas.

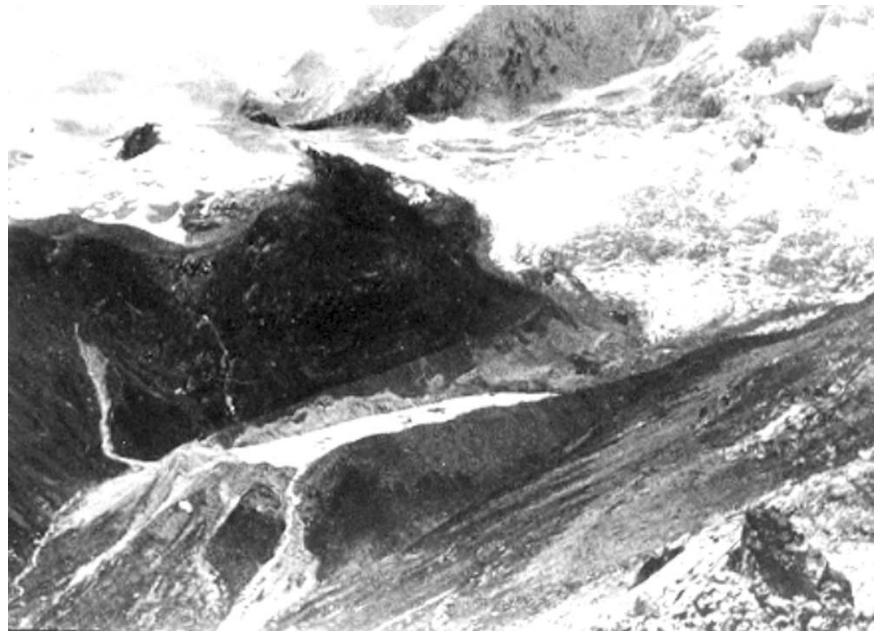
Fig. 4 Palcacocha Lake in 1932 (photo by H. Kinzl)

Based on the picture by H. Kinzl from 1932 (Fig. 4), it can be estimated that the Palcacocha Lake had filled up to 4610 m a.s.l. prior 1941. This lake water level was 47 m higher than the present one of 4,563 m a.s.l. (Zapata et al. 2004). The estimated volume of the Palcacocha Lake before its rupture on December 13, 1941 based on the topographic maps was between 9,000,000 and 11,000,000 m³. The water filled up the lower lake (Jircacocha) in the Cojup valley causing failure of its moraine dam and following outburst. The lower lake was completely emptied and contributed by its volume of approximately 4,800,000 m³ to the flood, which reached the City of Huarás killing about 4,000 inhabitants (Electroperu 1984) and destroying about 970,000 m² of the city along the Quilcay River.

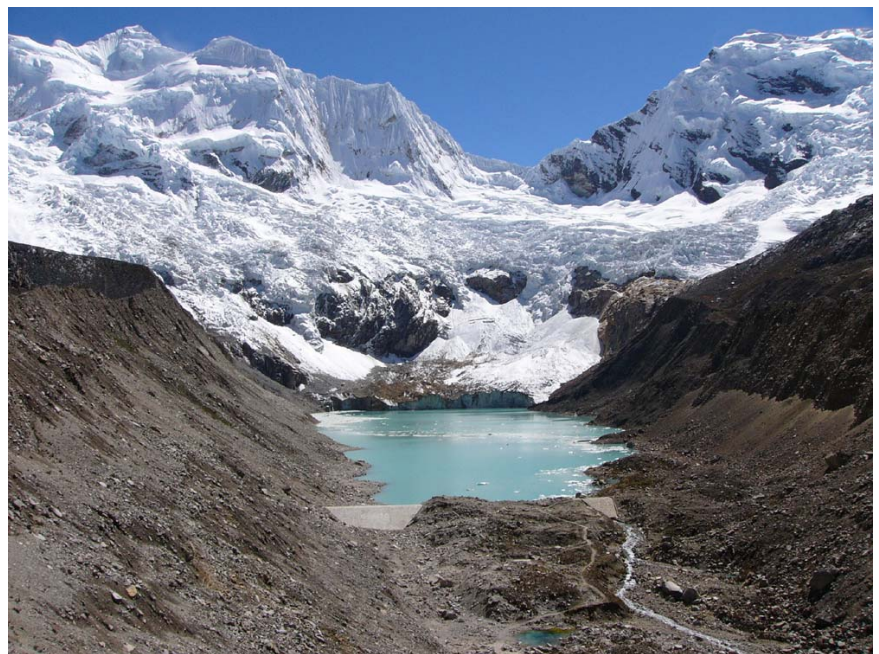
Fig. 5 Front view of the Palcacocha Lake in September 2004 showing the two artificial concrete dams (photo by Z. Patzelt 2004)

After the 1941 event, the water level dropped down and nowadays it is retained behind an 8 m high basal moraine dam. This natural dam was reinforced with two concrete overflow spillways built in its lowest portions during 1972–1974. The left (south) overflow spillway has a 33 m long evacuation channel, which controls the water level in the lake (Fig. 5). These preventive measures lowered the water level by 1 m (Ojeda 1974) resulting in a volume of 514,800 m³ and an area of 62,600 m². Glacial retreat which occurred mainly during the last 21 years (with a strong acceleration between 1999 and 2003) caused an increase of the lake volume 7.7 times to 3,690,000 m³ while the lake area increased 5.5 times to 342,332 m² (Zapata et al. 2004). Its maximal depth increased from 13 m up to 14.9 m, but the water level remained at the same elevation as in 1972. The increase of the depth is due to the fact, that the lake was enlarged in the area where the natural basin is deeper (this area was up to now filled with glacier).

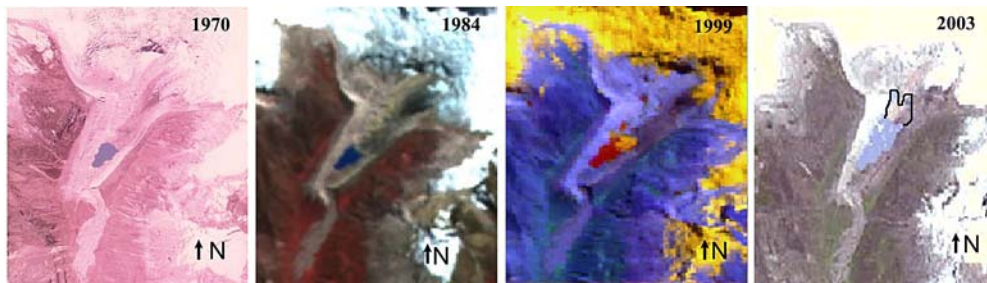
Fig. 7 Glacial tongue retreat as can be seen on the 1970 aerial photo, 1984 SPOT, July 1999 LANDSAT and March 2003 LANDSAT satellite images. Yellow color displayed on the July 1999 LANDSAT image indicates debris-free ice or snow. Black line on the March 2003 SPOT image displays glacier retreat identified during the bathymetric measurements in October 2003

There are many glacial lakes in the Cordillera Blanca Mountains with a well-documented glacial tongue retreat history (e.g. Kaser et al. 1996; Thompson et al. 2000). Unfortunately, no detailed monitoring information is available for the Palcacocha Lake. Therefore, its glacial history was described with the help of aerial photographs and satellite images. Only a rough estimate about glacier terminus position based on the H. Kinzl photo's (Fig. 4) can be made for the time prior 1941. We concluded that the glacier tongue was either in the similar position as mapped by the 1970 aerial photo or few tens of meters closer to the glacier amphitheatre. On other hand, the position of the glacial terminus on the 1970 aerial photo (Fig. 7) can be very well identified. The maximal length of the lake was 405 m at that time. Just a very little (if any) change can be detected by comparison of the 1970 aerial photo with the 1984 SPOT satellite image. It means that the glacier terminus retreated only by several meters or remained on the same position as in 1970. The irregular yellowish spot at the tip of the glacier terminus shown on the July 1999 LANDSAT image was interpreted as almost debris-free ice or snow floating on the lake disconnected from the glacier tongue itself. Based on the field observations from 2003 we assume that these loosen floated ice blocks melted during the year 1999. Therefore, the final glacier retreat between 1984 and 1999 was up to 340 m within 15 years. Similar scenario is suggested for the year 2003. The large part of the glaciated area shown on the March 2003 SPOT image consisted of broken floating ice blocks, which melted within the next 7 months. This was proved by March and October field investigations. The bathymetric measurements from October 2003 proved a total glacier retreat of 530 m between 1999 and 2003. The presented data show a total retreat of the Palcacocha Lake glacier tongue of about 760 m from 1970 to October 2003 (within 33 years)!

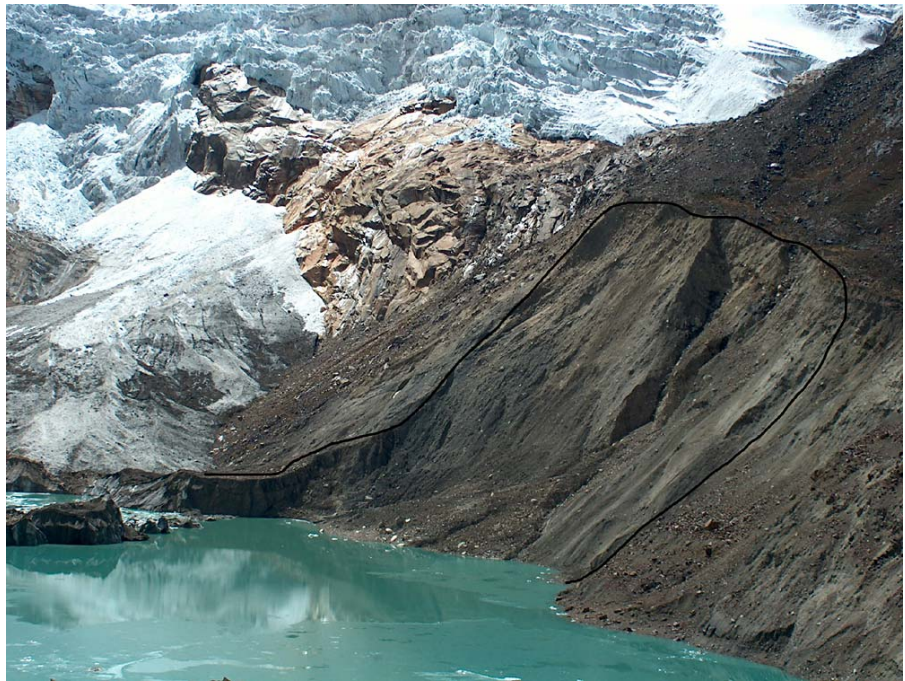
Fig. 8 NE view of the March 19, 2003 landslide area indicated by the narrow black line (photo by J. Klimes, July 2003)

On March 19, 2003, a planar landslide of unconsolidated material of the inner moraine fell into the lake water and hit a part of the glacial tongue (see Fig. 8). The main triggering factor of the landslide was extensive rainfall precipitation which over-saturated the moraine material. No evidence about permafrost involvement has been found. Rough volume estimate of the landslide is between 50,000 and 75,000 m³. This high uncertainty is due to only a proximate knowledge of the pre-landslide slope topography and to the fact that almost the entire landslide accumulation lies on the lake floor. The impact of the material produced a tidal wave more than 8 m high, which overflowed the natural and artificial parts of the lake dam and caused a minor flood in the Cojup stream and the Quilcay River. The sediments carried by the flood blocked the water treatment plant of Huarás.

between the inner and the outer slopes of the Palcacocha Lake moraine dam (see Fig. 8). The 1970 aerial photo interpretation revealed two debris flows on the outer slopes and five debris flows along with two landslides (indicated only by scarps) on the inner slopes. The time of the origin of these debris flows and landslides is unknown. Since 1970, no new debris flows have occurred on the outer slopes in contrast to the inner slopes where one large planar landslide occurred in March

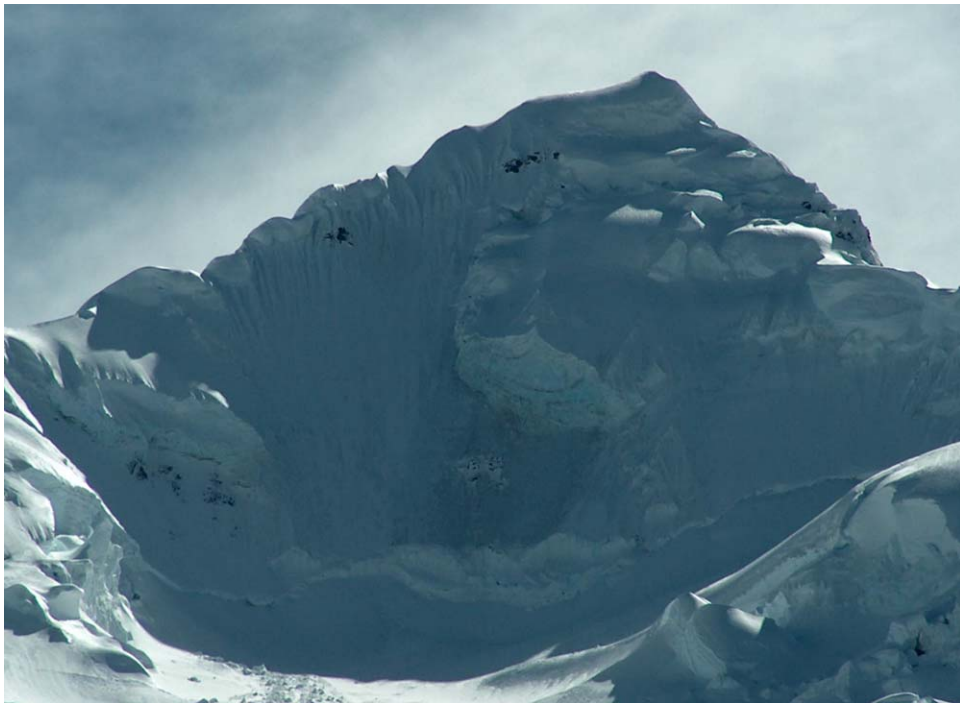
Fig. 9 Potentially dangerous ice block bellow the Nevado Palcaraju (6,264 m a.s.l) in the starting zone of snow avalanches. Vertical height shown is about 200 m (J. Klimes, July 2003)
